Engineer Intelligence Dossier
Strategic Study MARIANAS
Subfile 19 ANALYSIS OF THE
NATURAL ENVIRONMENT

MILITARY GEOLOGY OF SAIPAN, MARIANA ISLANDS

VOLUME I

INTRODUCTION AND ENGINEERING ASPECTS

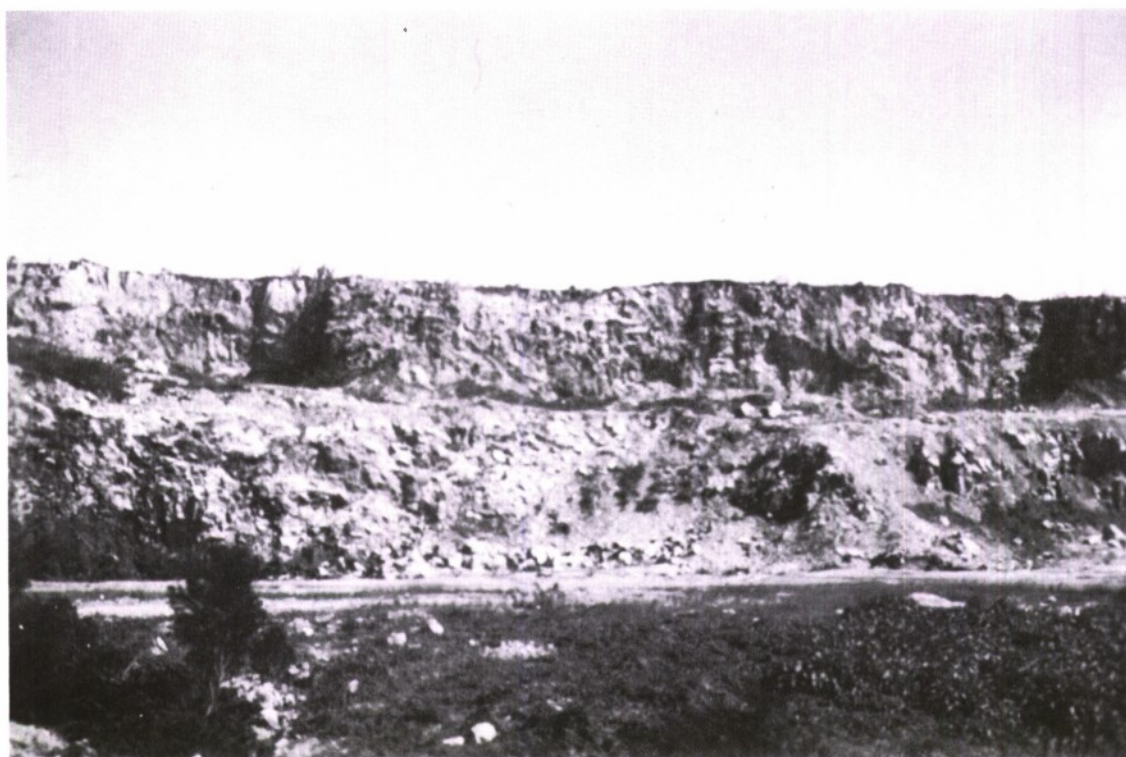
A. Unit No. 1 Very compact limestone. Quarry S-25 at Laderan Dago, south-central Saipan. Sample site No. 2.

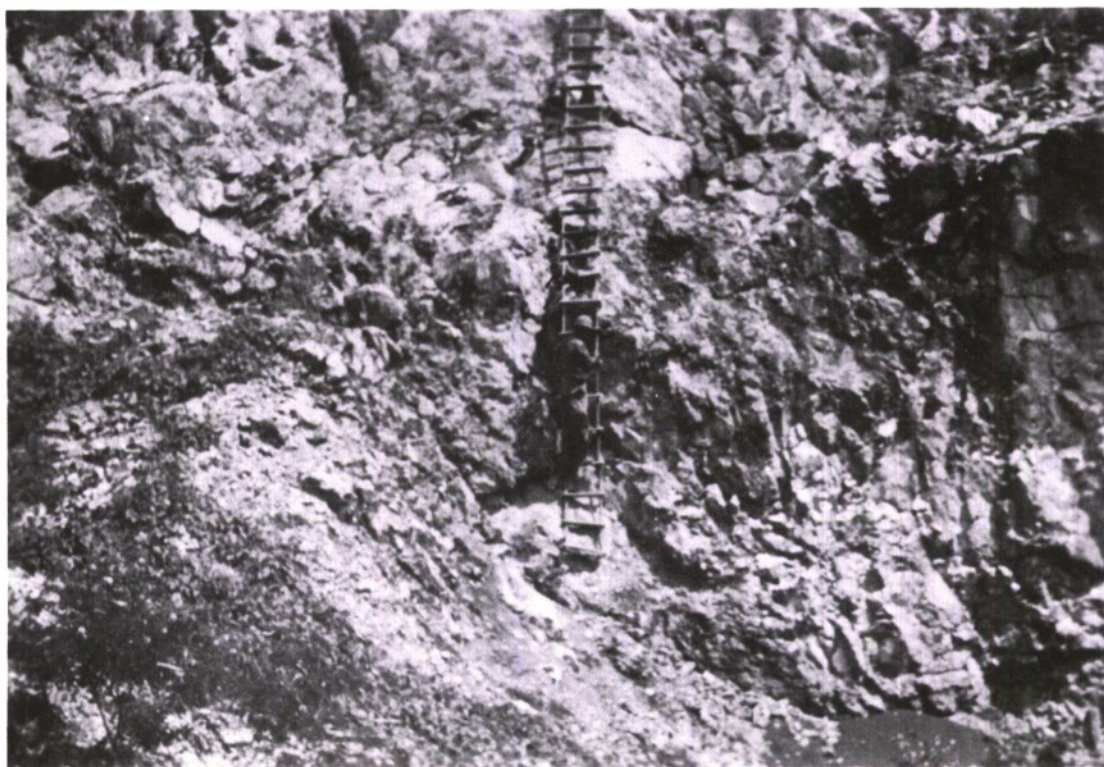
B. Unit No. 1 Very compact limestone. Quarry S-25 at Laderan Dago, south-central Saipan. Sample site No. 2.

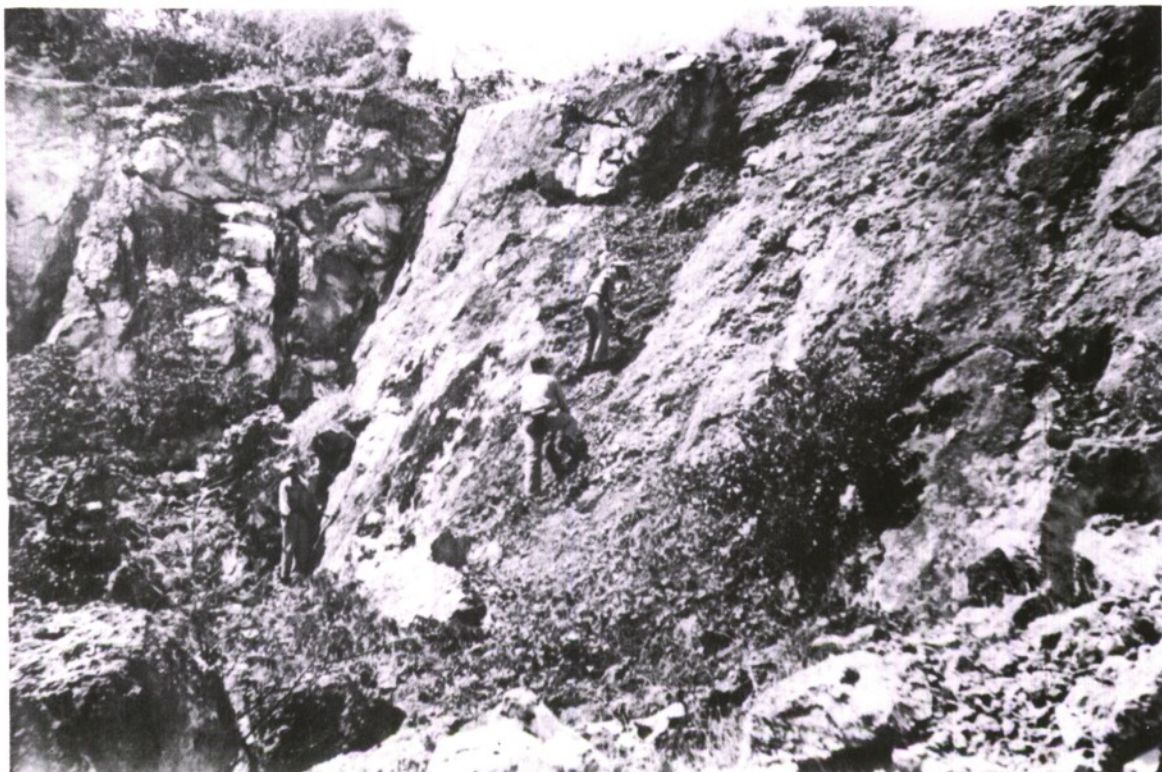
A. Unit No. 1 Very compact limestone. Quarry S-2 at south side of Laderan Laguna, northeast Saipan.

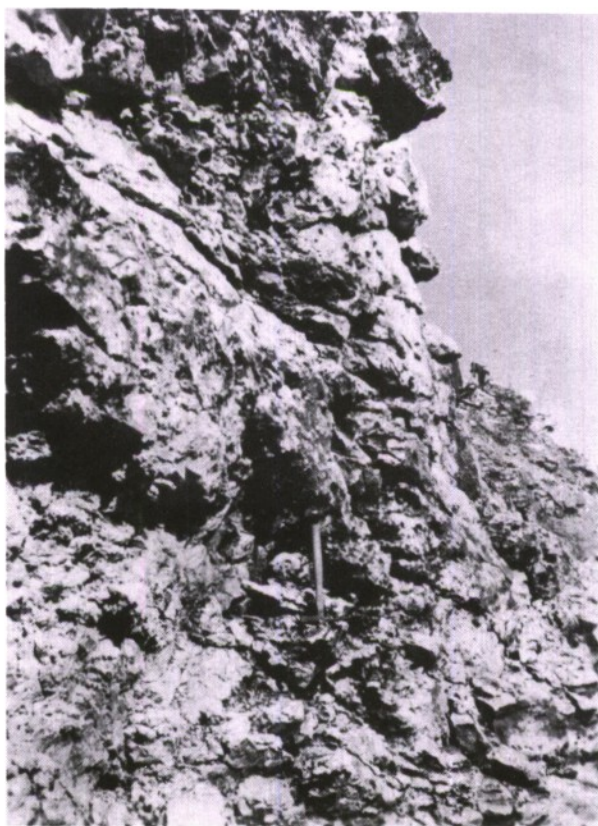
B. Unit No. 2 Firm, porous limestone. Quarry at Laderan Dandan, southeast Saipan.

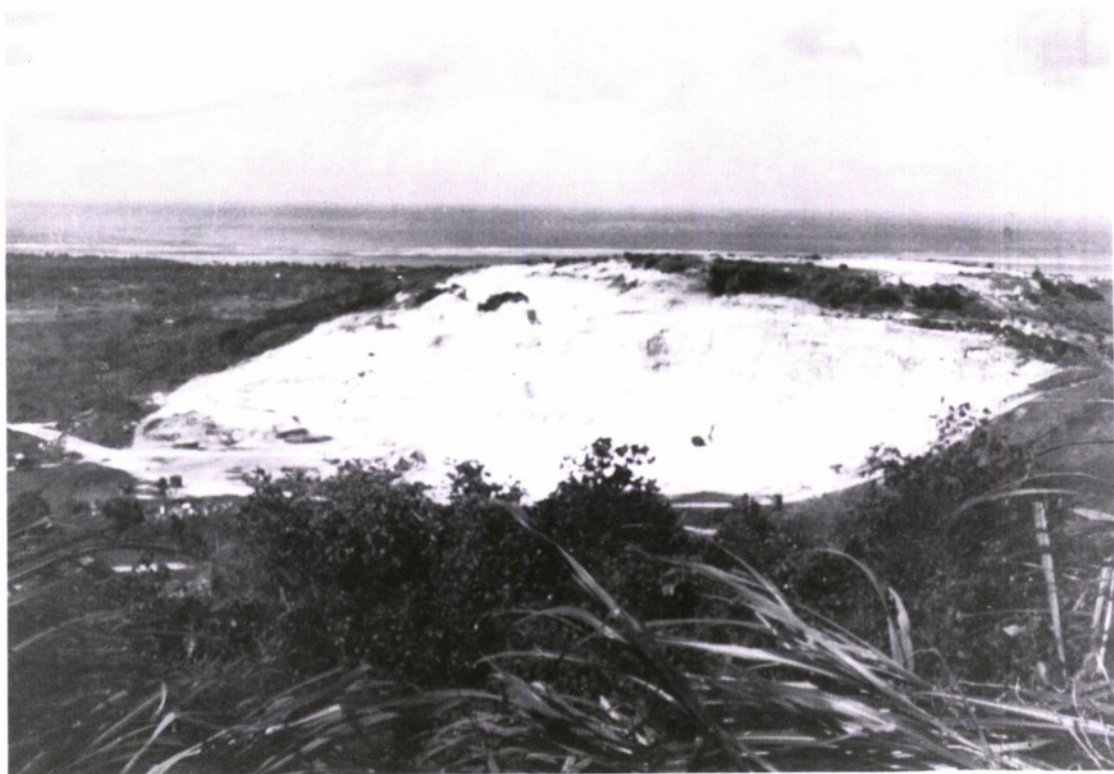
A. Unit No. 3 Coralline rubble. Distant view of Quarry S-16 at Laderan Dandan, south-central Saipan. Sample site No. 1.

General description: The rock is a loose, rubbly, brecciated or fractured, clastic limestone, containing angular particles of semi-indurated to chalk-like limestone in a matrix of fine limy sand, and locally, some clay. Individual particles are commonly up to several inches in diameter; masses larger than one foot are uncommon. Its color is ordinarily white or light tan; exposed surfaces are discolored gray by algae and similar vegetation. Typical exposures are shown in plates 8A, 8B, 9A, 9B, 10A, and 10B.

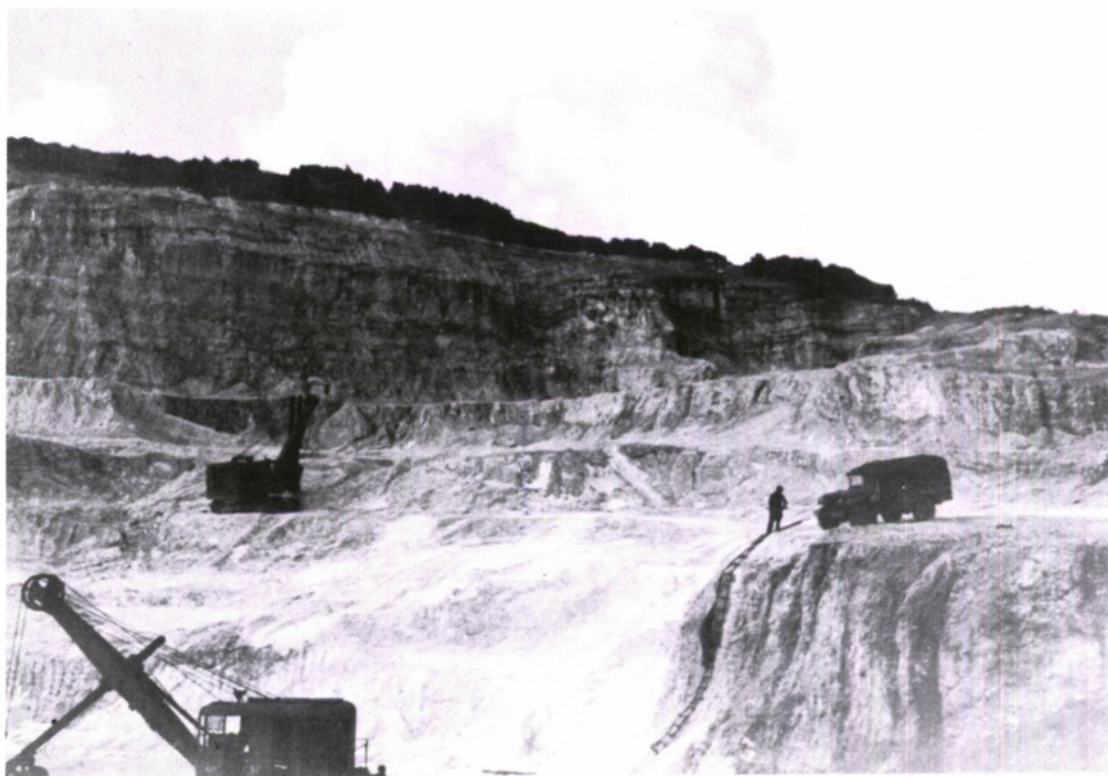
B. Unit No. 3 Coralline rubble. Close-up view of quarry S-16 at Laderan Dandan, south-central Saipan. Sample site No. 1.

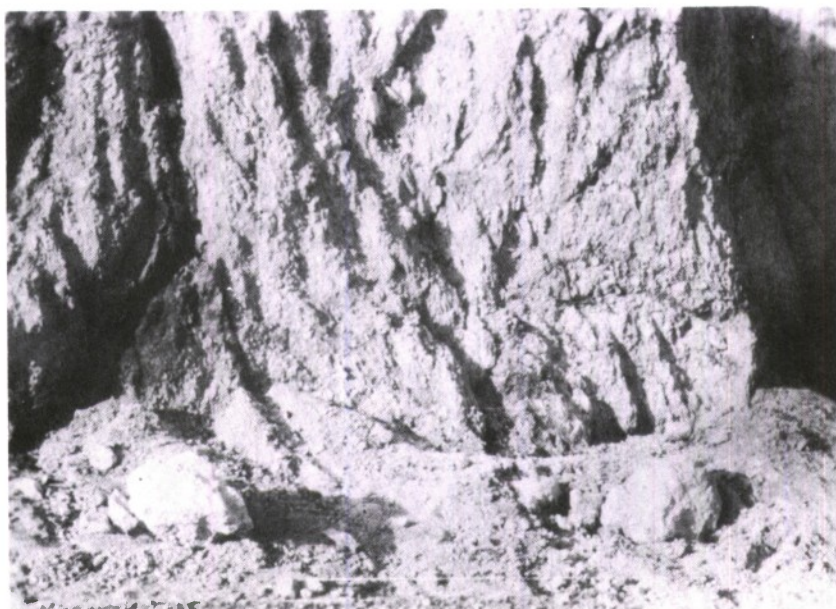
A. Unit No. 3 Coralline rubble. Quarry S-16 at Laderan Dandan, south-central Saipan. Sample site No. 1.

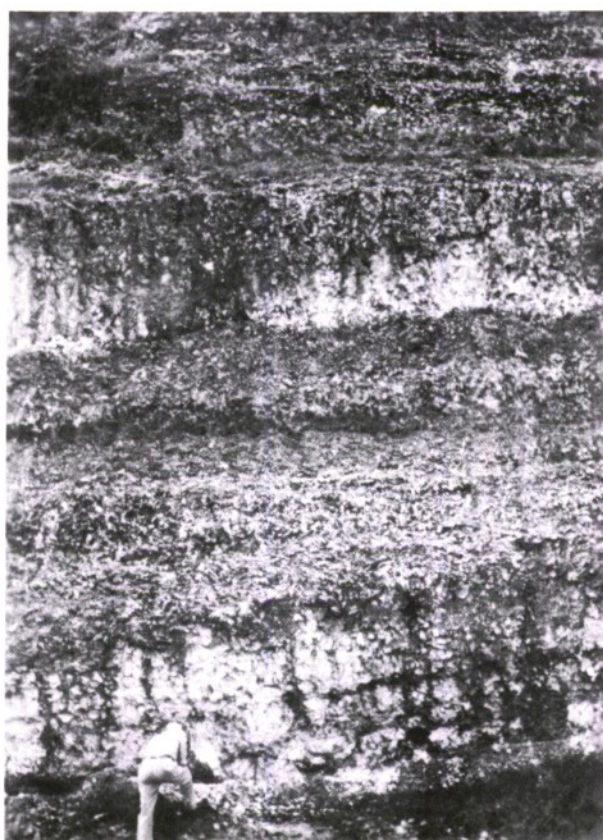
B. Unit No. 3 Coralline rubble. Quarry at base of Laderan I Agag, east-central Saipan.

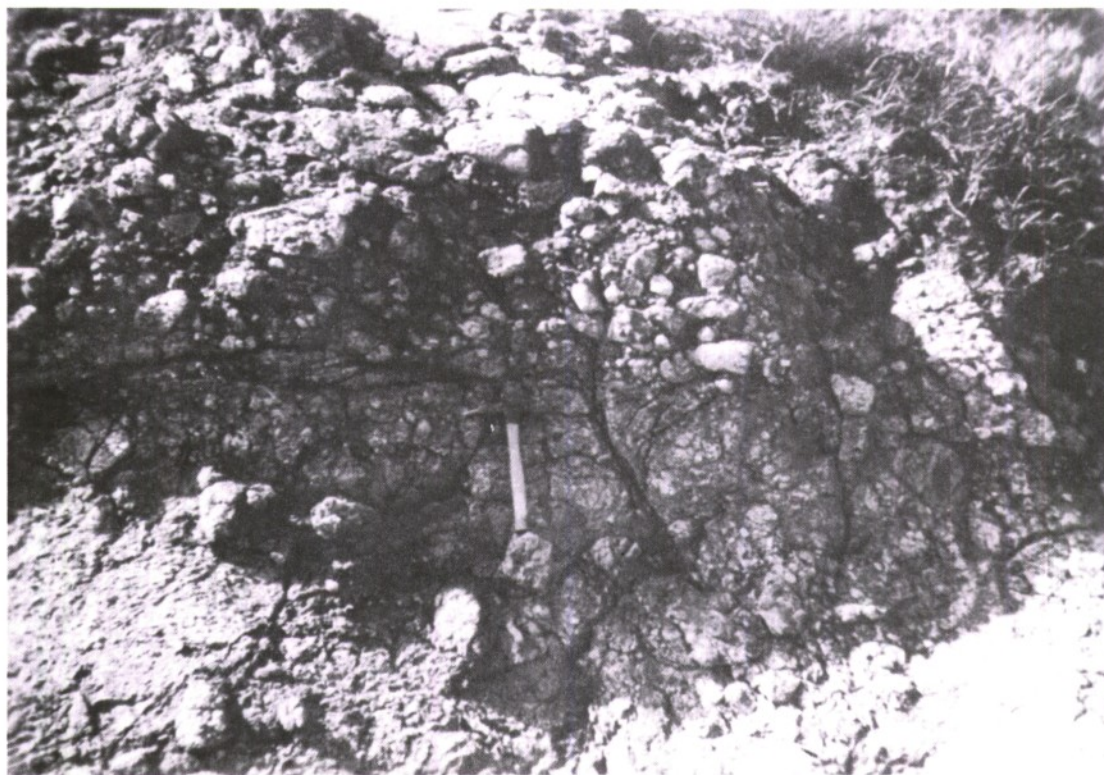
A. Unit No. 8 Weathered andesitic conglomerate and breccia.
District of Talofoto, northeast Saipan.

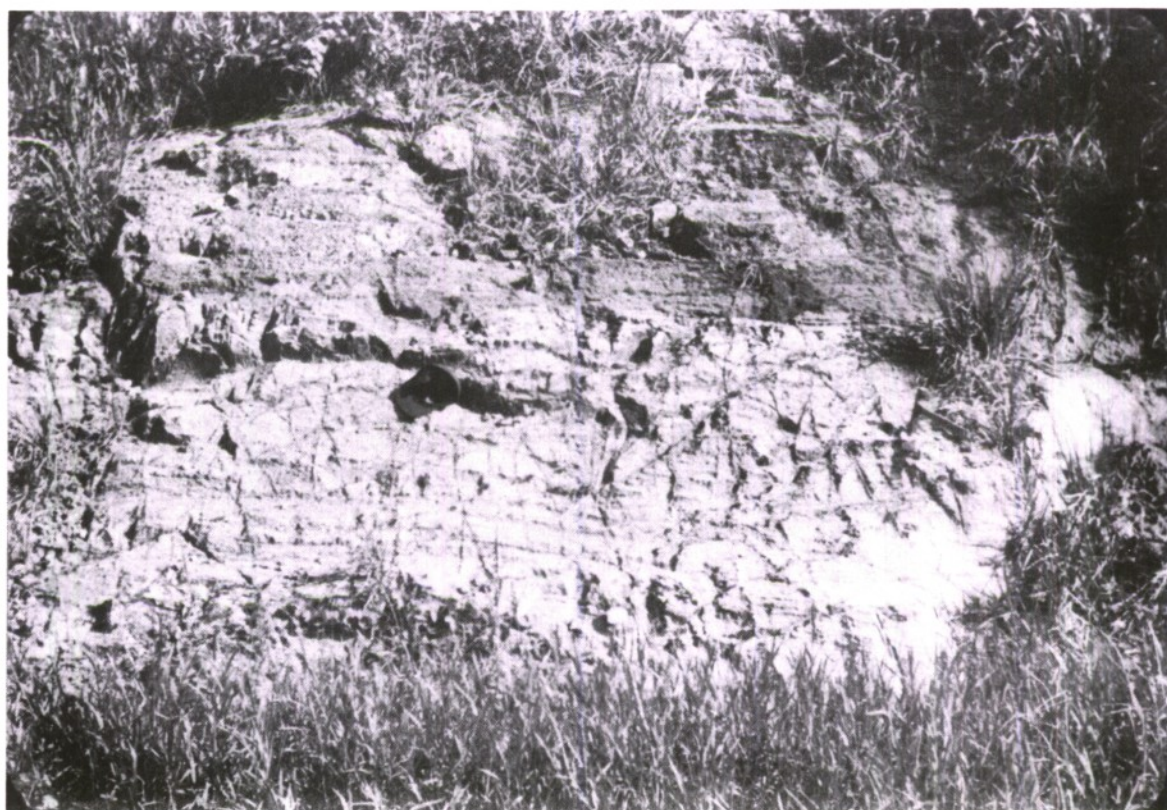
B. Unit No. 8 Weathered andesitic conglomerate and breccia. Cut
along west side of Cross-Island Highway, district of Papago, east-
central Saipan.

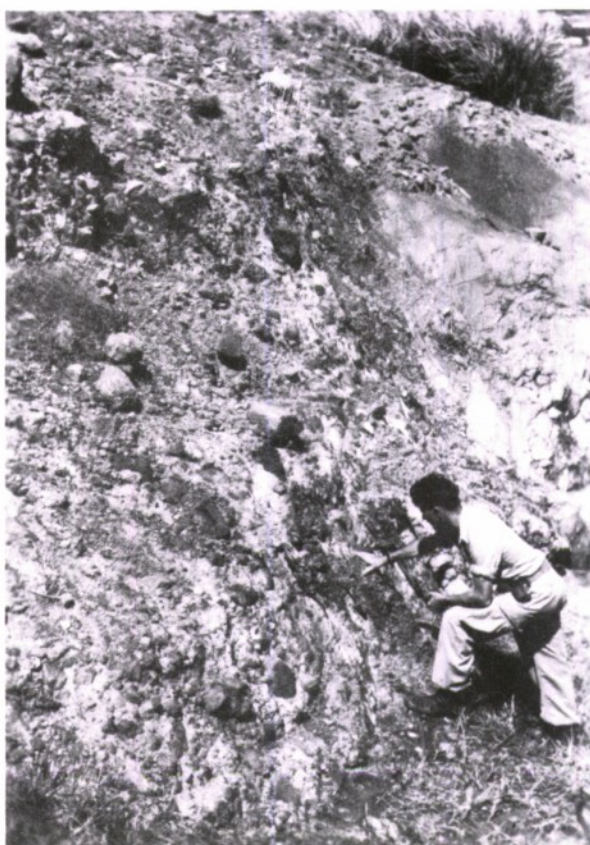
A. Unit No. 9 Partly weathered andesitic conglomerate and sandstone. Road cut at Laderan Hagman, eastern Hagman Peninsula, east-central Saipan. Sample site No. 1

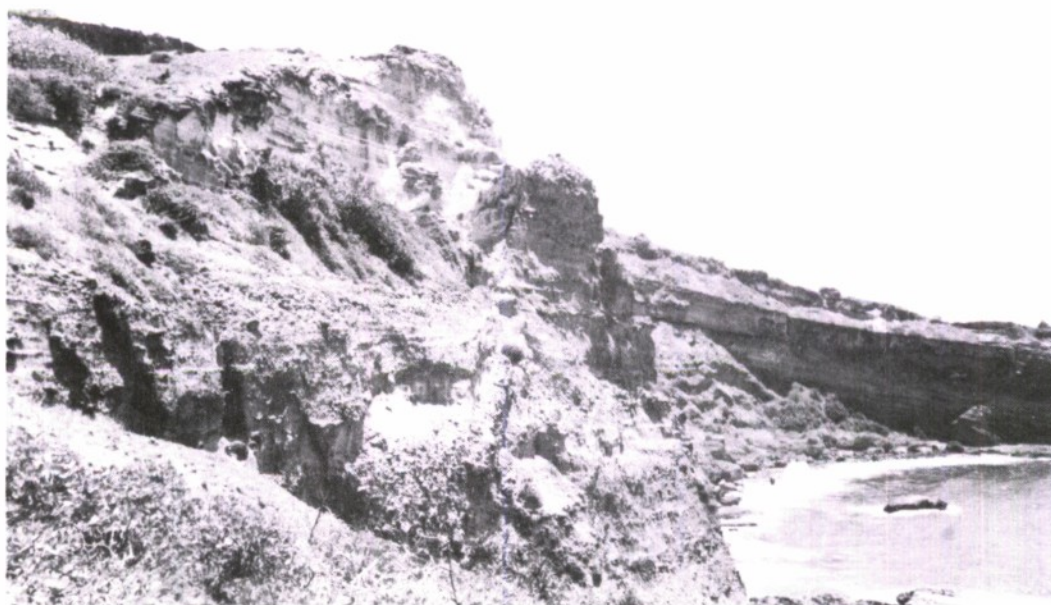
B. Unit No. 9 Partly weathered andesitic conglomerate and sandstone. Bluffs above Unai Hagman, eastern Hagman Peninsula, east-central Saipan.

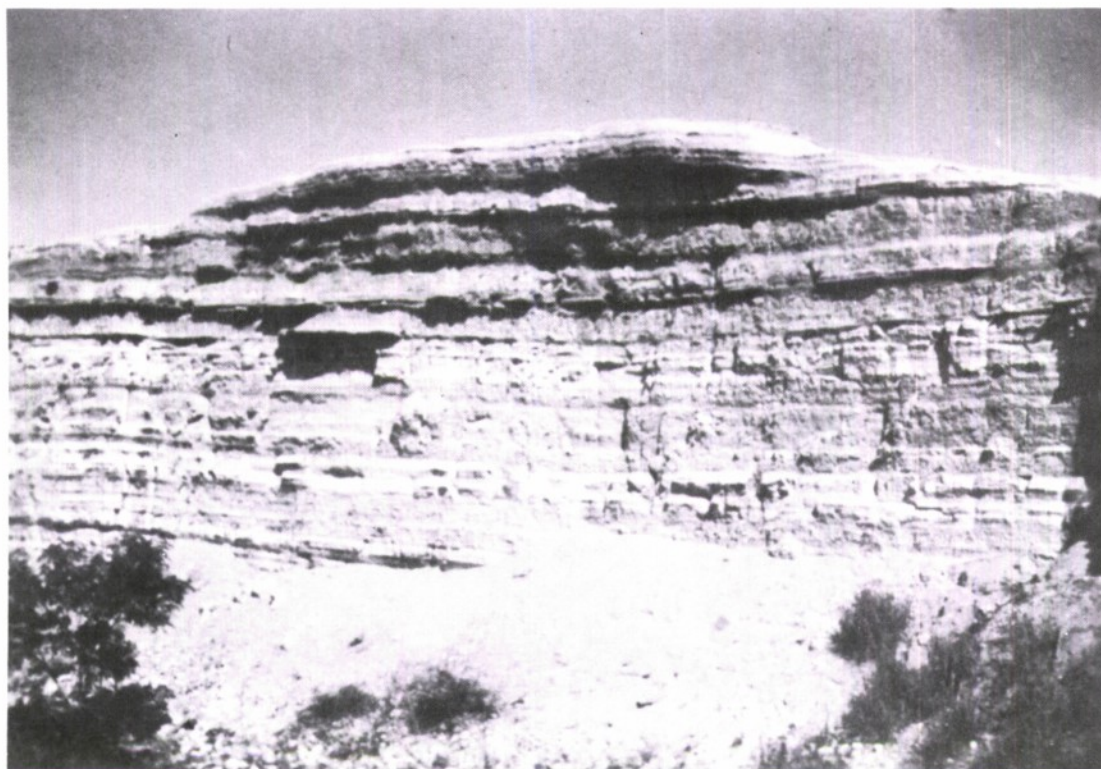
A. Unit No. 10 Clayey volcanic sediments. Quarry at Laderan Dago, about 800 feet east of Isley Entrance Road, south-central Saipan. Sample site No. 2.

General description: Stratified layers of silt, silty clay, sandy clay, marl, and weakly-cemented, calcareous, tuffaceous sandstone; silt and clay layers predominate. Maximum thickness of this unit is approximately 200 feet. Individual beds range from a few inches to several feet in thickness and are various shades of brown, green, gray, and red; they are inclined generally eastward at moderate angles, and in some areas are gently folded, deeply incised, and eroded. Some beds are partly bentonitic, and swell when wet. Textural and compositional differences between beds, undulations caused by folding, and erosion account for exposure of dissimilar layers at different locations within the unit. Typical exposures are shown in plates 16A and 16B.

Quarries: Extremely limited development. The only observed excavation is near Isley Field, at the north end of Laderan Dago, in south central Saipan, at the site from which a test sample was taken.

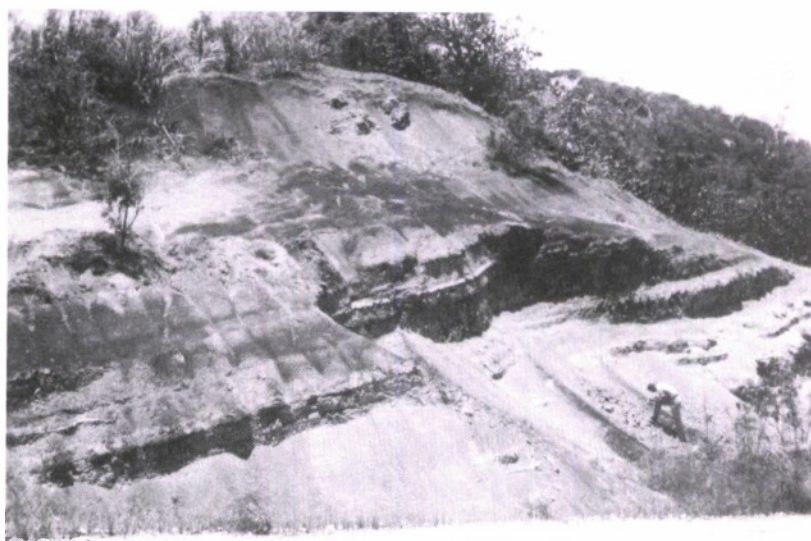
B. Unit No. 10 Clayey volcanic sediments. Cut along East Coast Highway, district of I Hasngot, northeast Saipan.

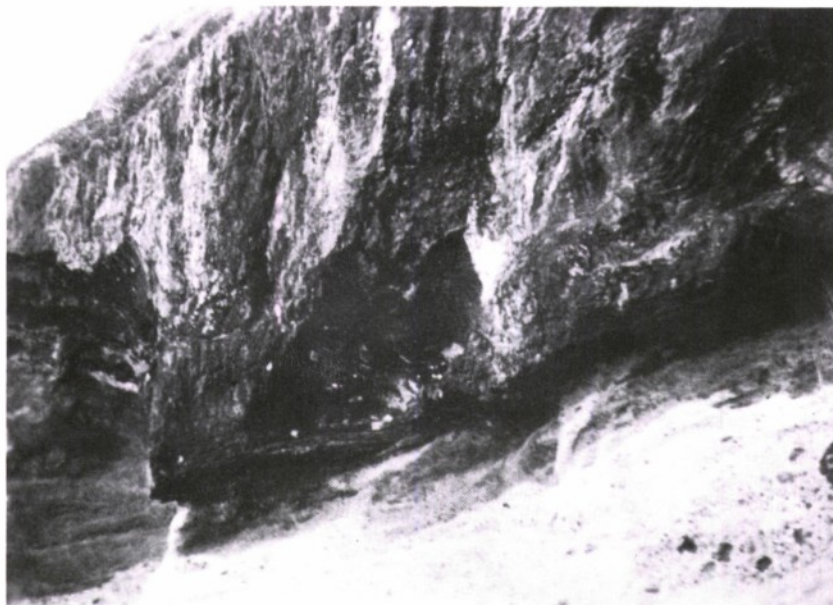
A. Unit No. 11 Compact dacite in upper part. Unai Fanunchuluyan, northeast Saipan.

General description: Fairly hard, massive, compact, glassy, porphyritic dacite rock; closely jointed and fractured. Contains extremely hard, but brittle, siliceous zones. Commonly intercalated with and overlain by unit 12. Typical exposures are shown in plates 17A, 17B, and 18A.

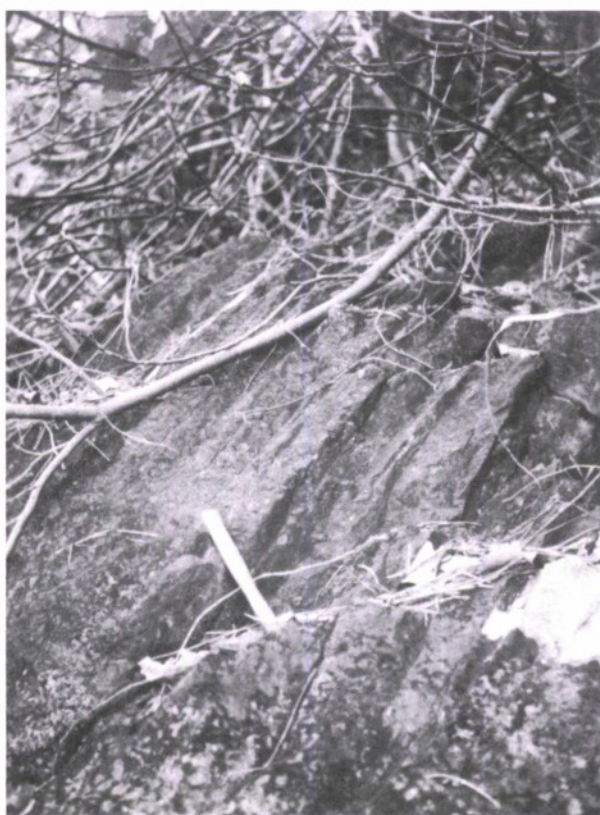
B. Unit No. 11 Compact dacite. In valley on southwestern flank of Ogso Achugau, northeast-central Saipan.

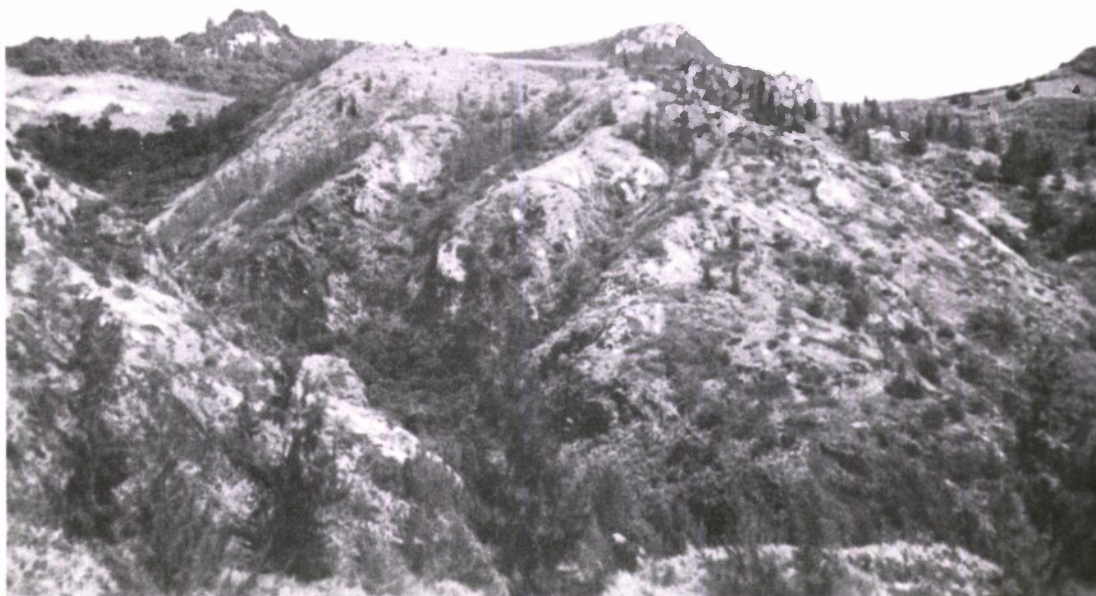
A. Units No. 11 and 12 Compact dacite, and friable dacitic breccia and tuff. Achugau district, northeast-central Saipan.

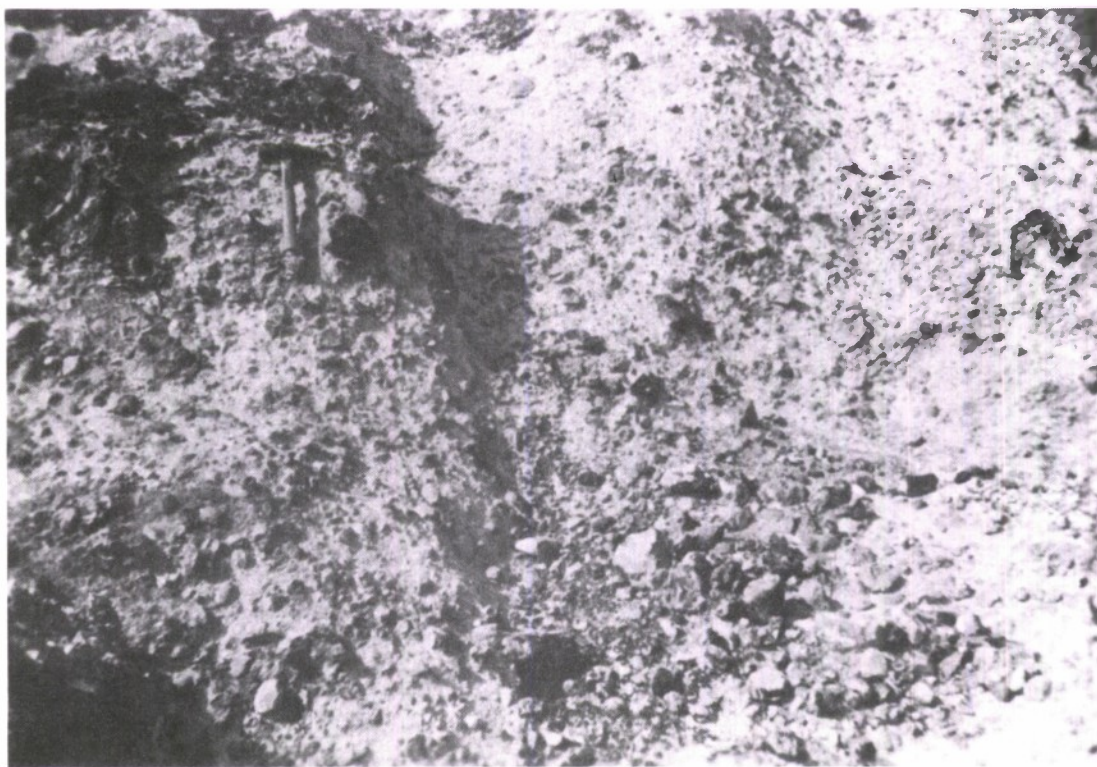
B. Unit No. 12 Friable dacitic breccia. Southeast slope of Ogso Achugau, northeast-central Saipan.

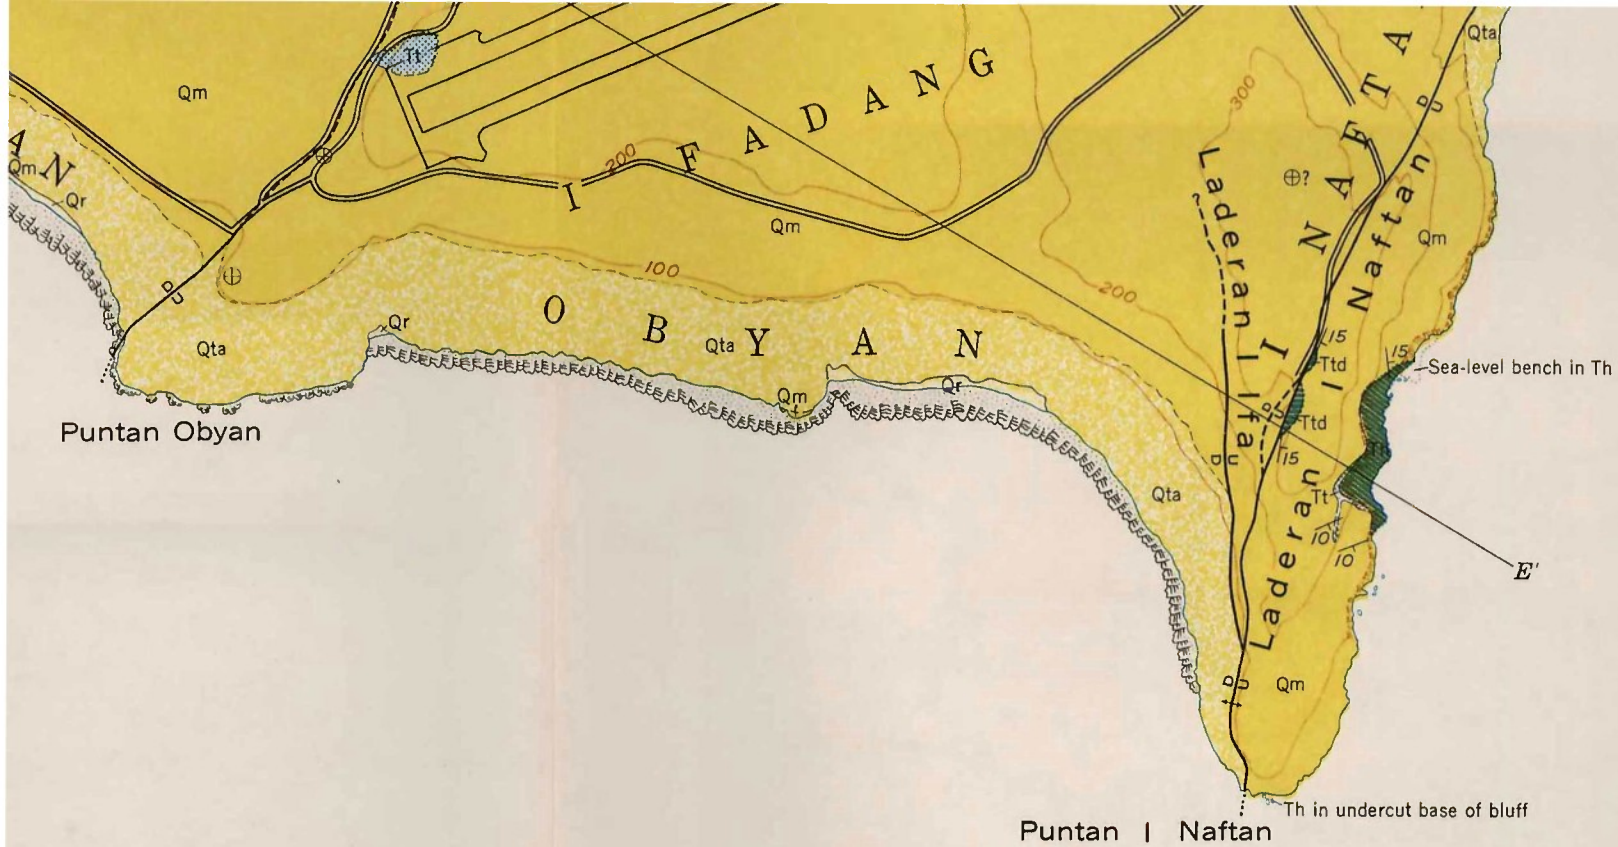
GENERALIZED GEOLOGIC MAP OF SAIPAN, MARIANA ISLANDS

Base adapted from U. S. S. Bowditch Survey of 1944;
Hydrographic Office Miscellaneous Chart 11,500-36.

Prepared by
Geological Surveys Branch
Intelligence Division, Office of the Engineer
HQ, United States Army Forces, Far East
with personnel of
the United States Geological Survey

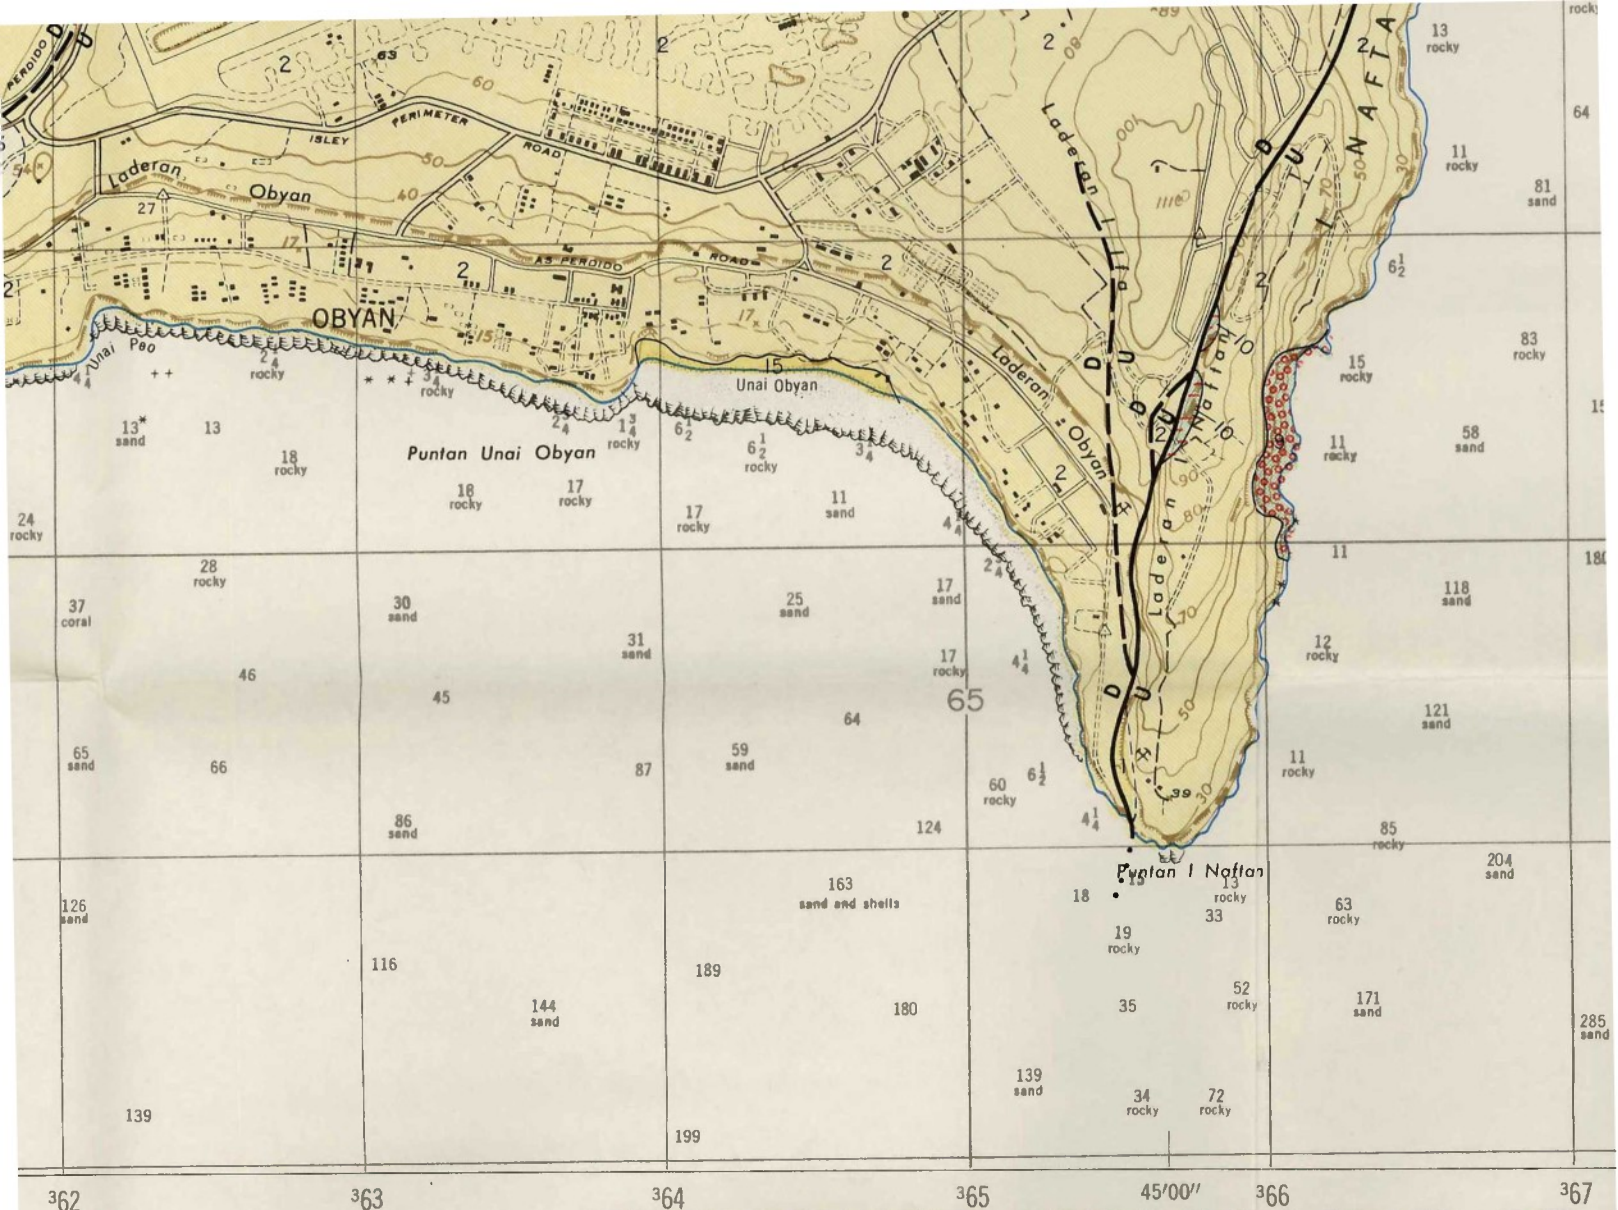
ENGINEERING GEOLOGY MAP OF S

Scale 1:25,000
